BAY SPRINGS MILL: HISTORICAL ARCHAEOLOGY OF A RURAL
MISSISSIPPI COTTON MI. (U) RESOURCE ANALYSTS INC
BLOOMINGTON IN W H ADAMS ET AL. 30 JUN 81 RAI-1427
C-07009(79)

Historical Archaeology of a Rural Mississippi Cotton Milling Community

RAI-1427

June 1, 1981

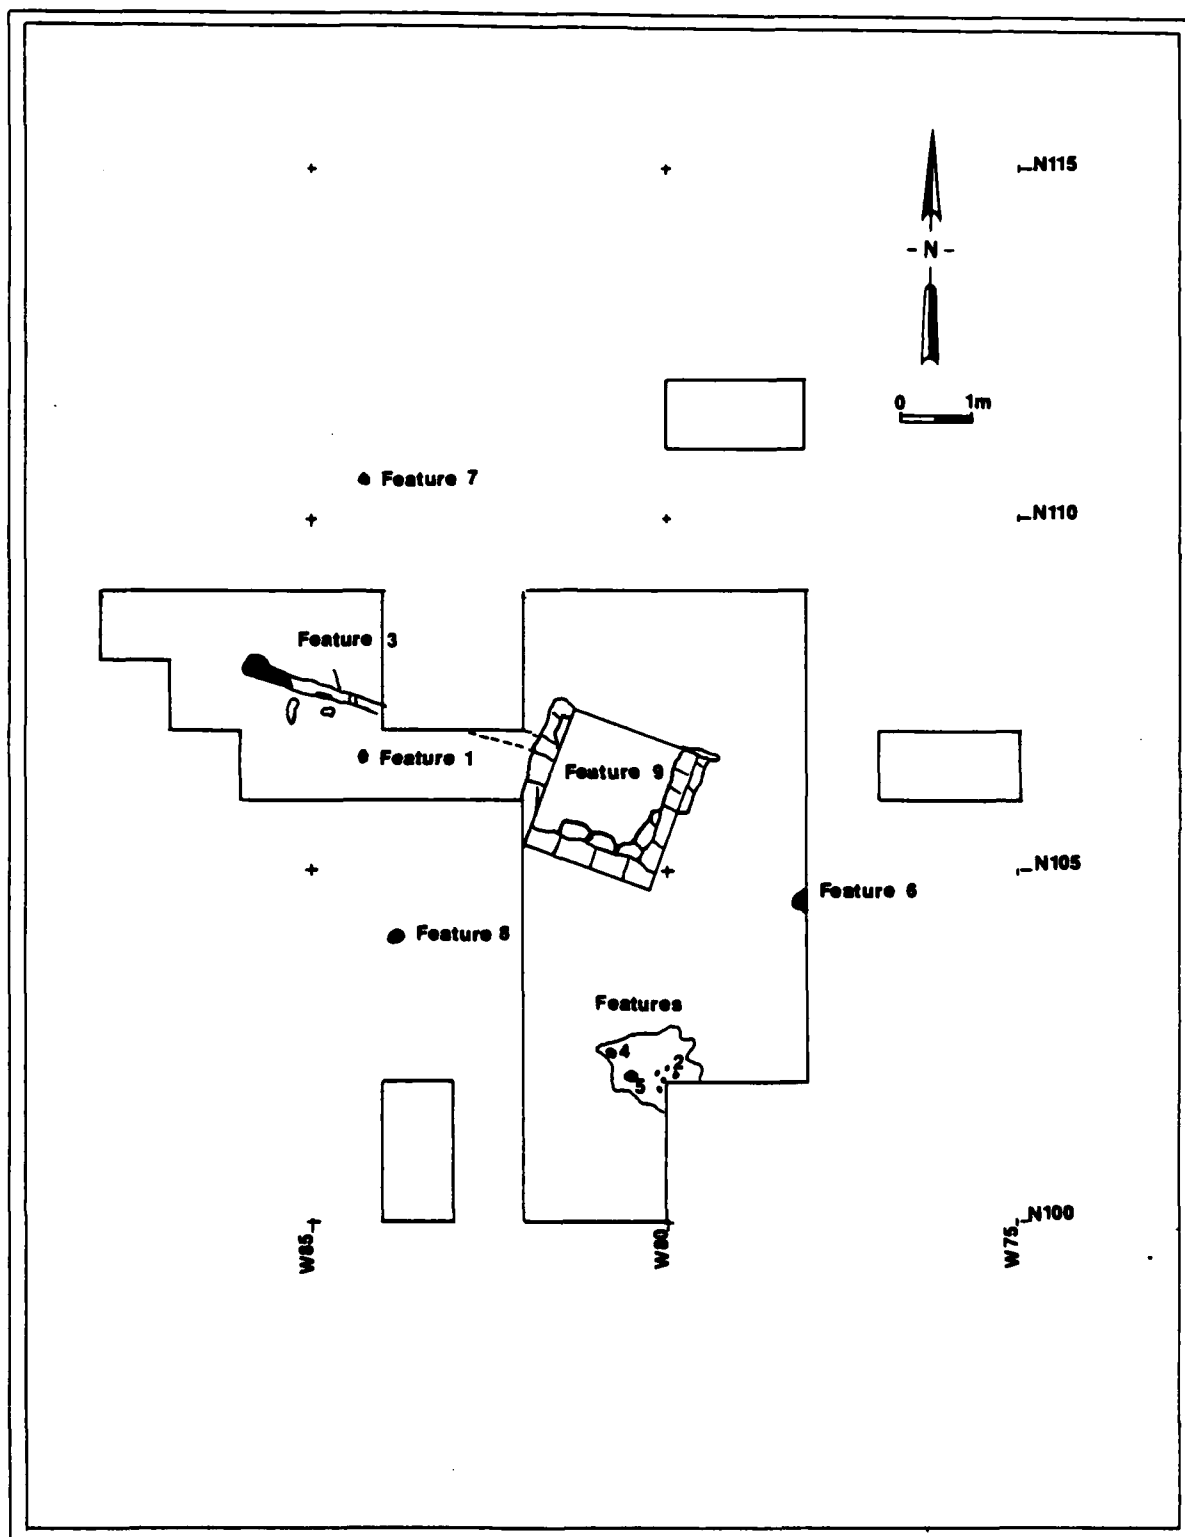
Figure 11.2.--Location of Features at Site 22TS1103A.

Feature 3 was a shallow trench filled with charcoal, running in a northwest to southeast direction through excavation Unit 8 (Figure 11.2). It was irregular in depth and width and was interrupted at one point along its length. At its widest point it was 20 cm and 5 cm at its deepest. The feature contained machine cut nails. Excavation Unit 7 was opened to intercept the feature and locate the corner of the structure. No corner was found there and the feature tapered to an end in the northeast corner of excavation Unit 17. No further evidence of the feature existed to the north or south. No similar features were seen to the west in excavation Units 12 or 16. If the length of Feature 3 actually depicts the eastern side of the structure, we can speculate as to the size of the structure. Assuming that the chimney was located in the center of the wall we can project a line east of the chimney equal in length to Feature 3. Feature 3 was 4.5 m from chimney to end. This would define a wall, to include the chimney, approximately 10.8 m ($4.5 \text{ m} \times 2 + 1.8 \text{ m}$) or 35 ft long--a rather large

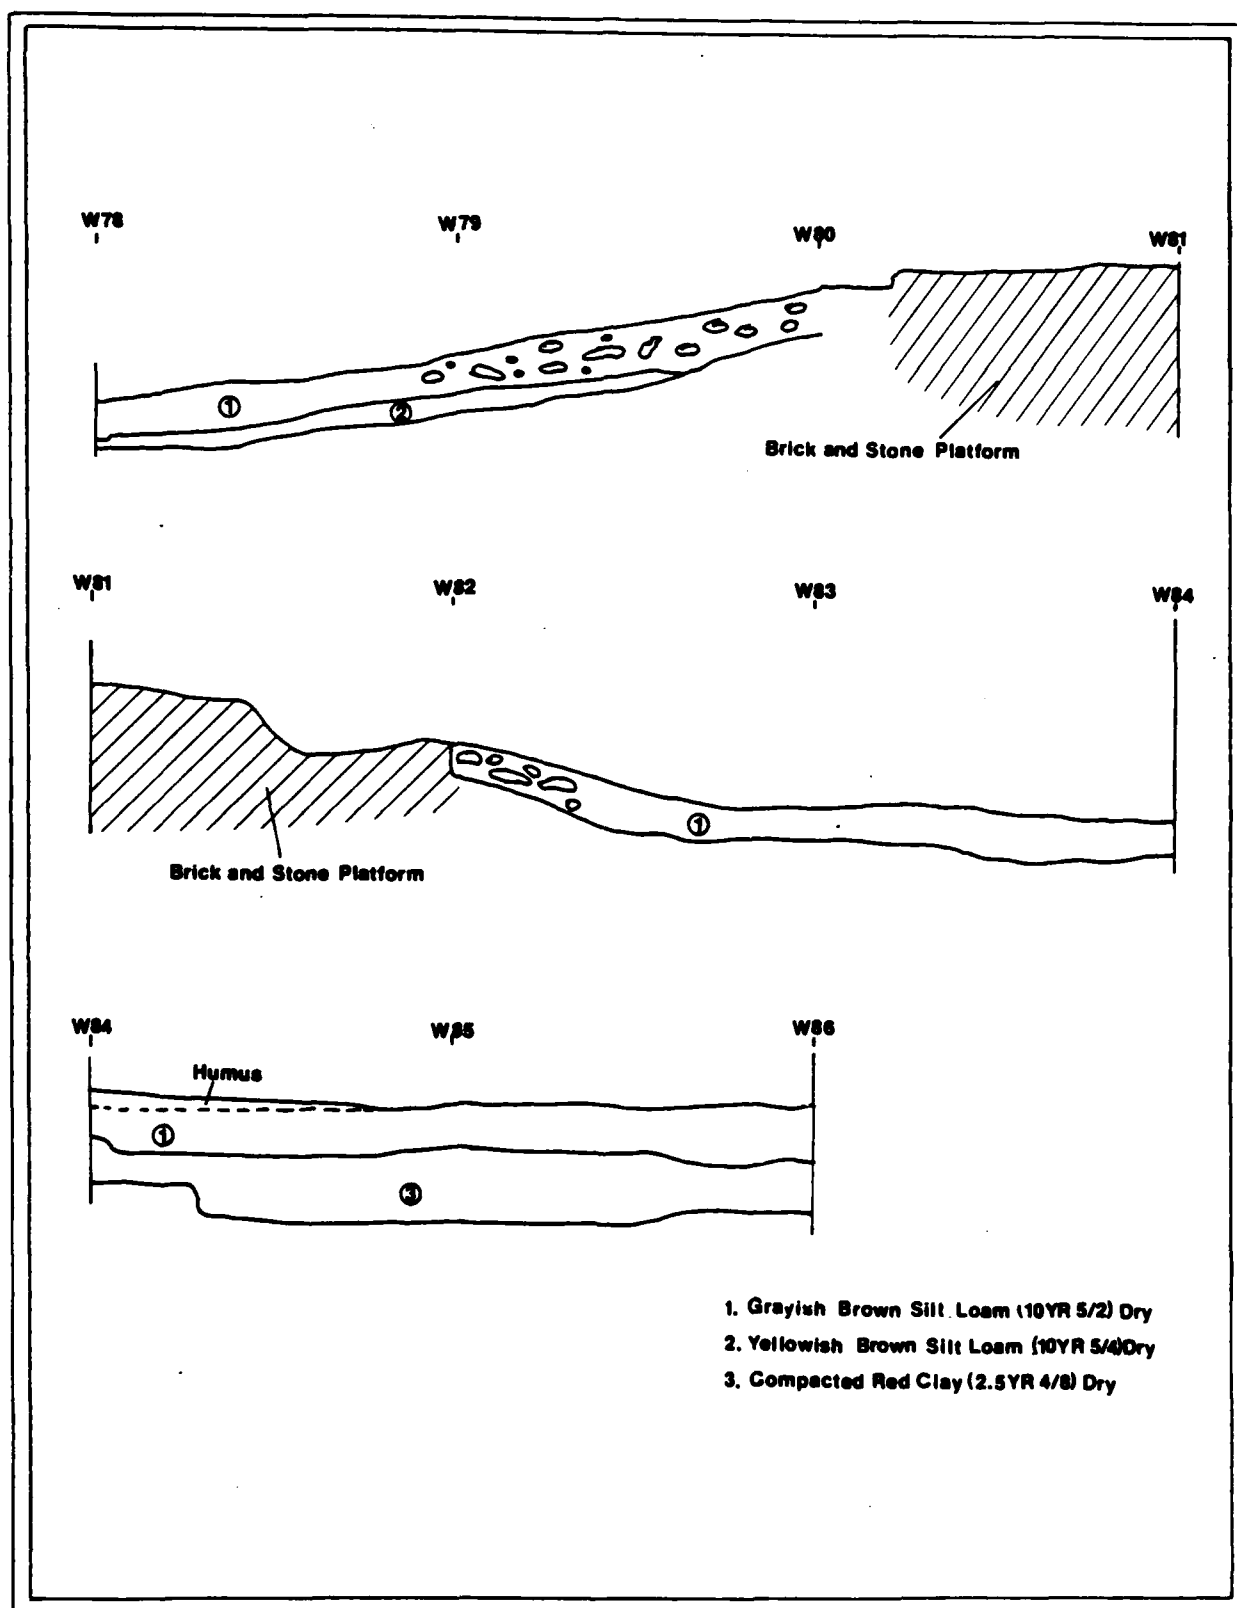
Figure 11.4.--Stratigraphy at Site 22TS1103A.

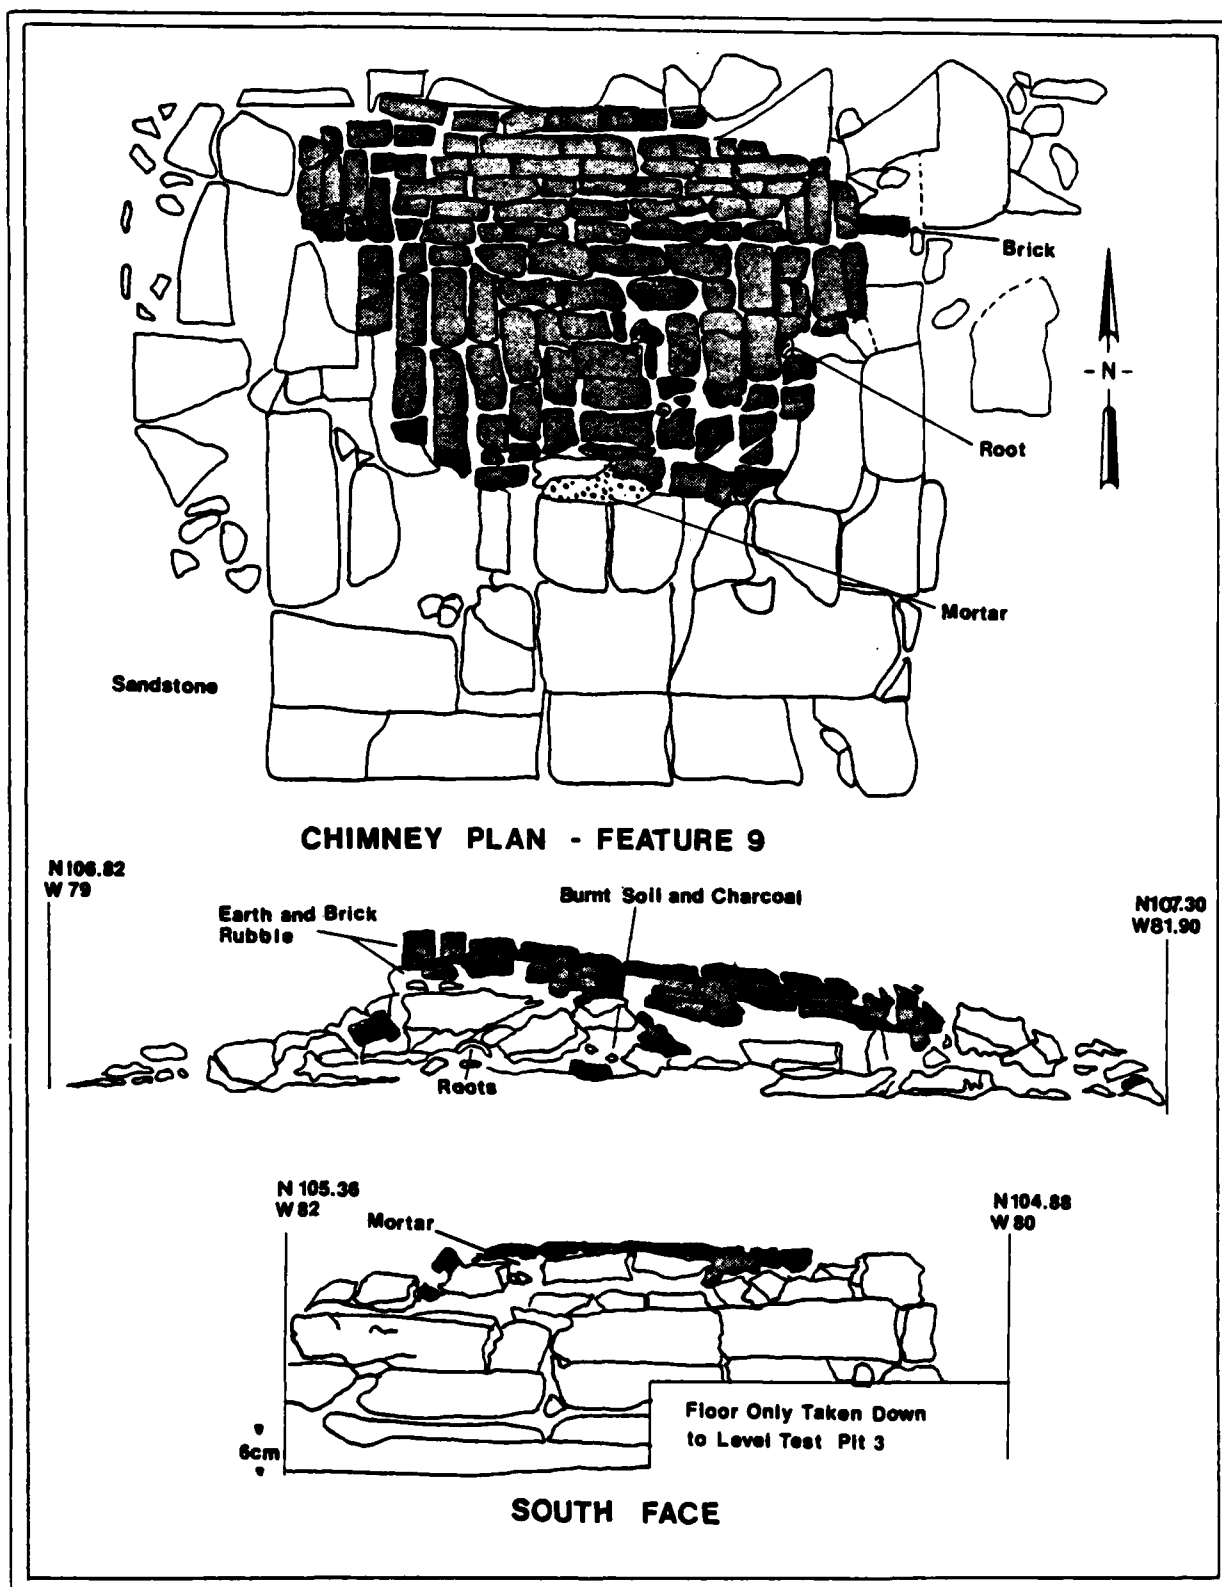
A total of nine cultural features were recognized during excavations (Table 11.1). Central to all was the chimney base (Feature 9). This base consisted of cut sandstone blocks topped with a brick pad (Figure 11.2). The sandstone blocks lay in three tiers, the bottom tier resting in the red clay to a depth of approximately 20 cm. This bottom tier was 1.80 m E/W by 1.9 m N/S. The second tier was stepped back 24 cm on the south side but not on the east, west, or north. This was true also of the top tier. The entire base plus brick was 56 cm high. While the southern part

Figure 11.5.--Chimney at Site 22TS1103A.

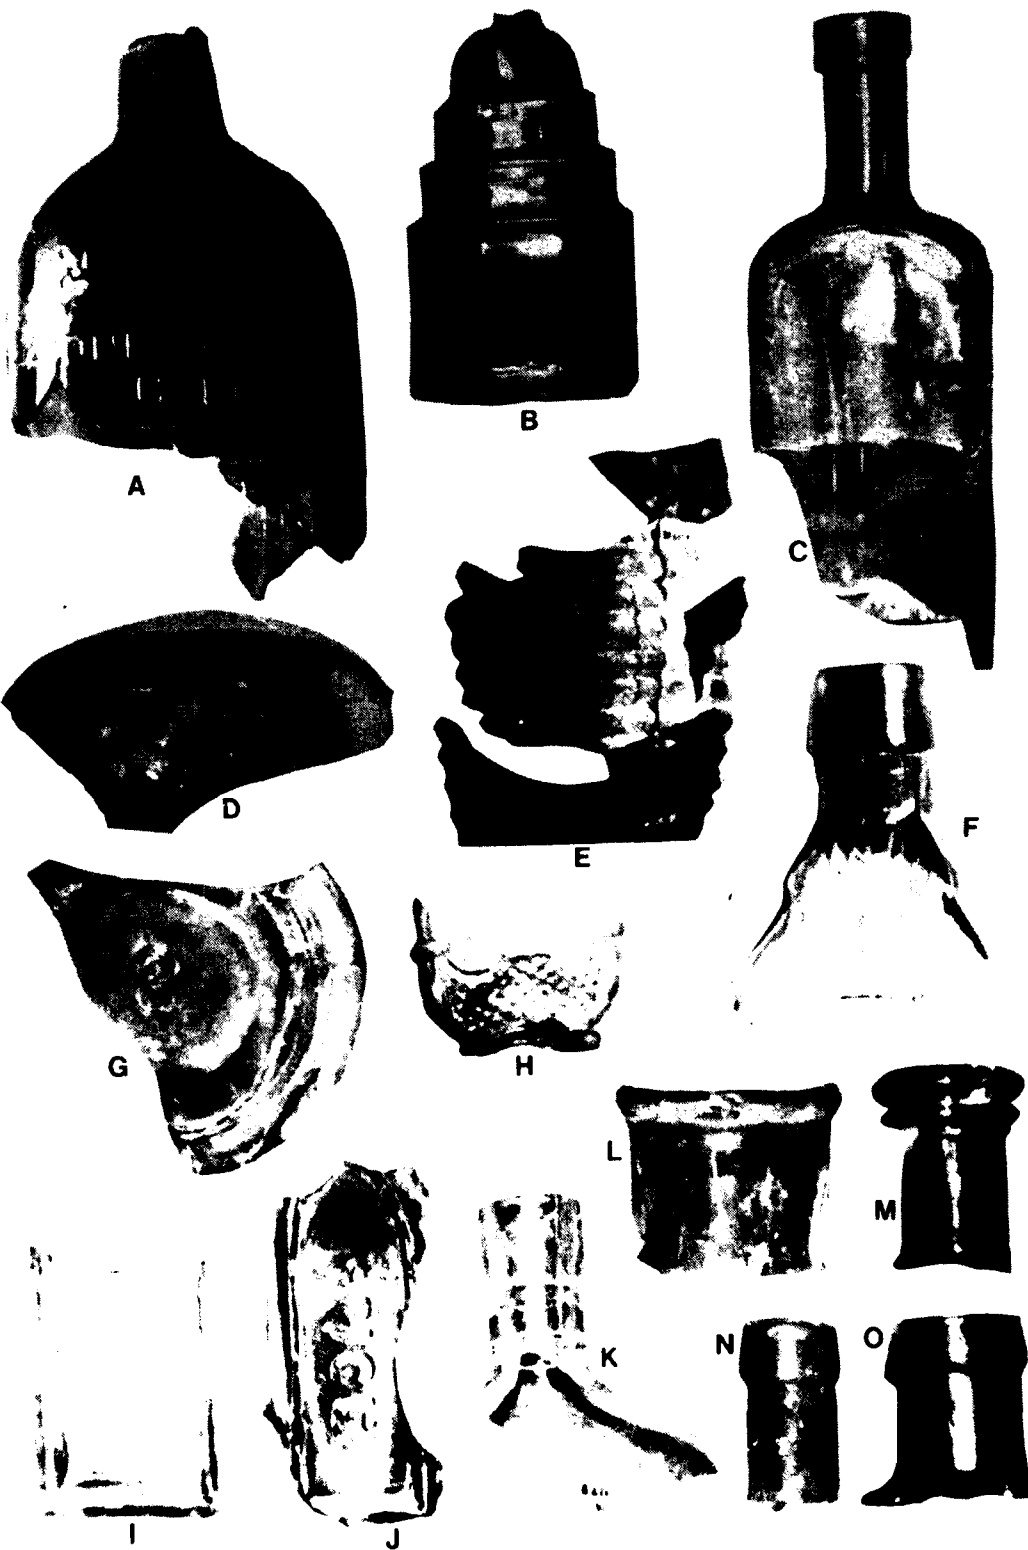
Glass Artifacts (Page 375)

A)	A01-37-01A	Warner's Safe Cure, oval bottle
B)	A01-36-01A	hexagonal bottle
C)	A01-35-01A	bevelled rectangular bottle
D)	A02-03-01B	Union oval bottle base
E)	A02-05-06K	round bottle base
F)	A01-34-01A	Drake's square bottle
G)	A06-02-03M	round jar base
H)	A02-35-01A	squared oval bottle base
I)	A02-12-02P	bevelled rectangular bottle base
J)	A07-02-02NN	lettered fragment, "SPICE"
K)	A03-08-13A	square cork lip, applied, bottle
L)	A05-04-03B	round patent, applied, jar
M)	A03-02-15A	cone patent lip, applied, bottle
N)	A03-08-01CC	tapered cork lip, applied, bottle
O)	A03-08-01V	tapered cork lip, applied, bottle

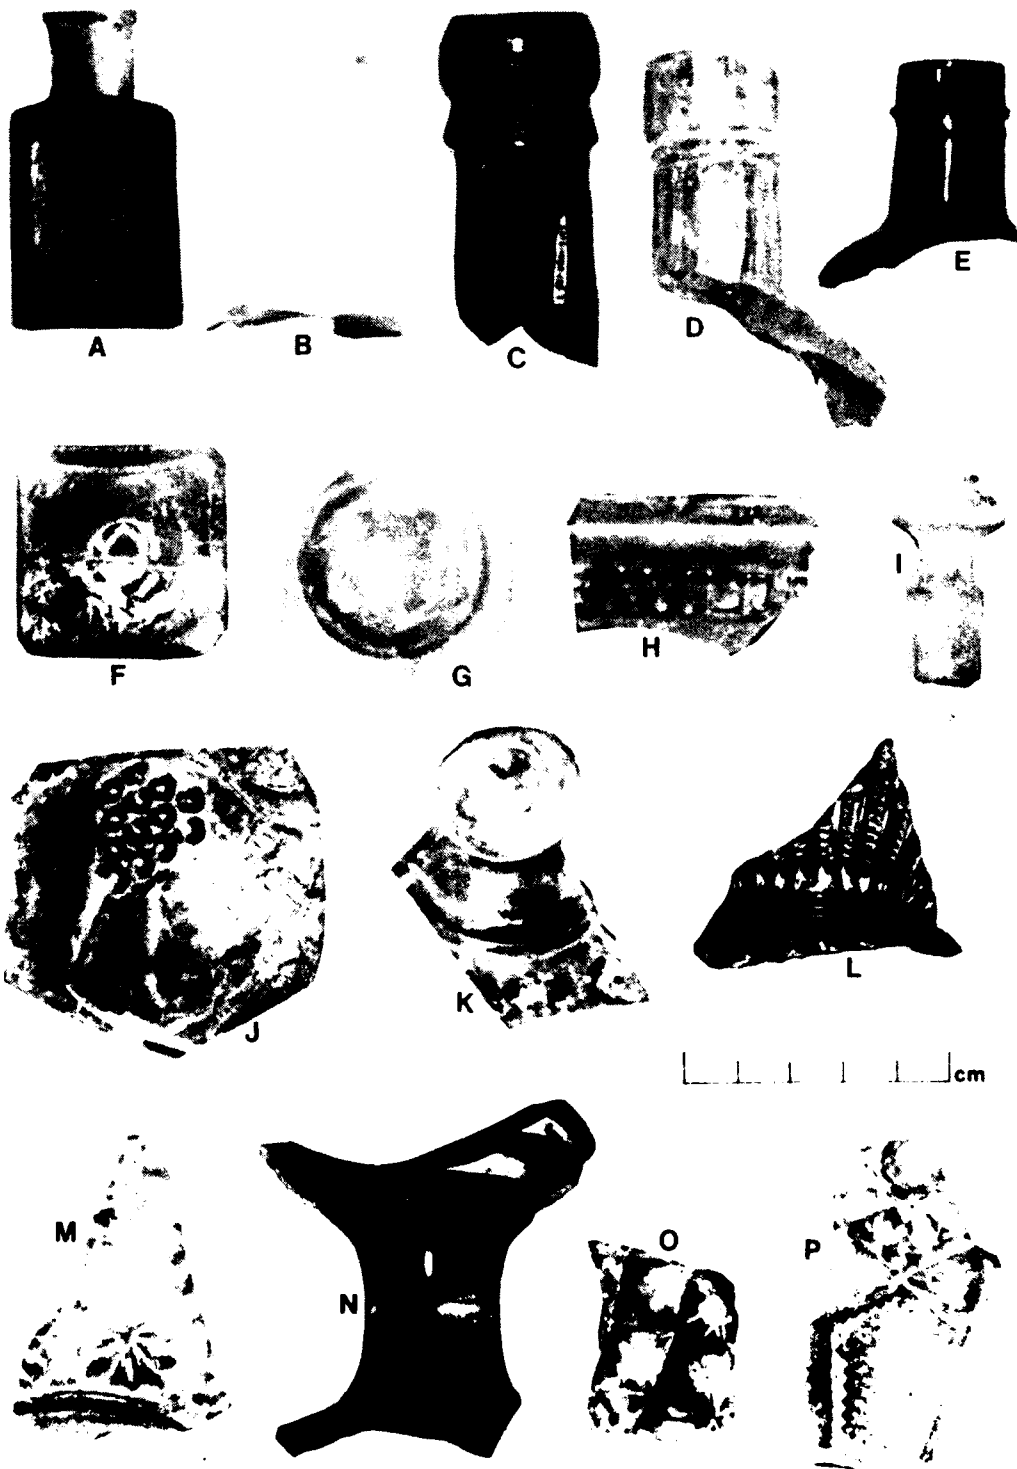
Glass Artifacts (Page 377)

A)	A01-12-05A	Dr. Sage's Catarrh Remedy
B)	A03-02-14B	round patent lip, applied, bottle
C)	A03-08-10B	round cork lip, applied, bottle
D)	A03-08-01Z	tapered cork lip, applied, bottle
E)	A03-09-02A	lug lip, machine made, bottle
F)	A02-08-03A	French square bottle base
G)	A08-04-01H	pressed glass base
H)	A07-02-02W	lettered fragment, "WILD..."
I)	A10-02-02D	glass stopper
J)	A07-06-02A	pressed glass fragment
K)	A08-02-01D	pressed glass lid
L)	A08-04-02M	pressed glass base
M)	A07-06-02B	pressed glass fragment
N)	A08-04-01G	pressed glass stem
O)	A08-06-01Z	pressed glass fragment, Sawtooth pattern
P)	A07-06-01D	pressed gla. fragment

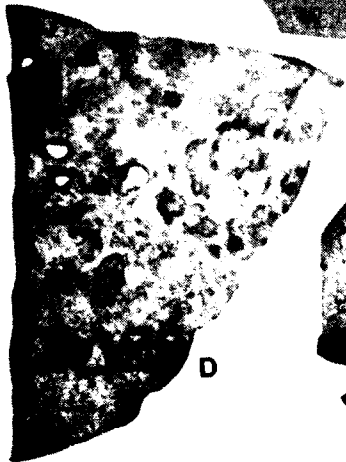
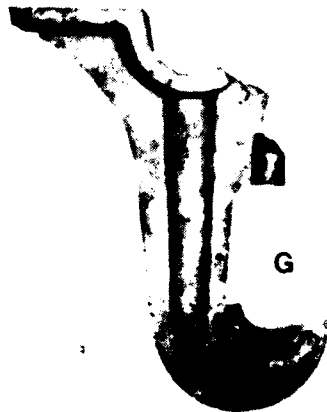
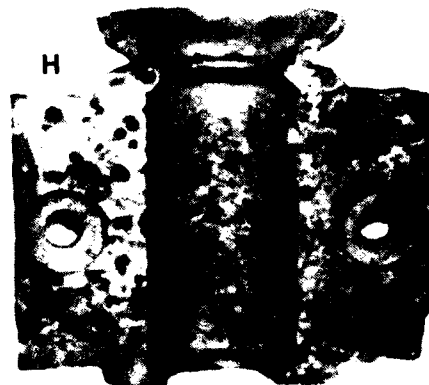
Carding Machine Parts and Power Transmission Parts (Page 387)

A)	F22-06-01C	bonnett frame part, "C. DANFORTH"
B)	F22-06-01F	bonnett frame part
C)	F22-06-01E	bonnett frame part, "PATTERSON, N. J."
D)	F22-06-01I	bonnett frame part, "PAT..."
E)	F22-06-03A	bonnett top fragment
F)	F22-06-04A	carding drum support stand
G)	F22-07-01A	line and jack shaft hanger
H)	F22-07-03B	cap bearing

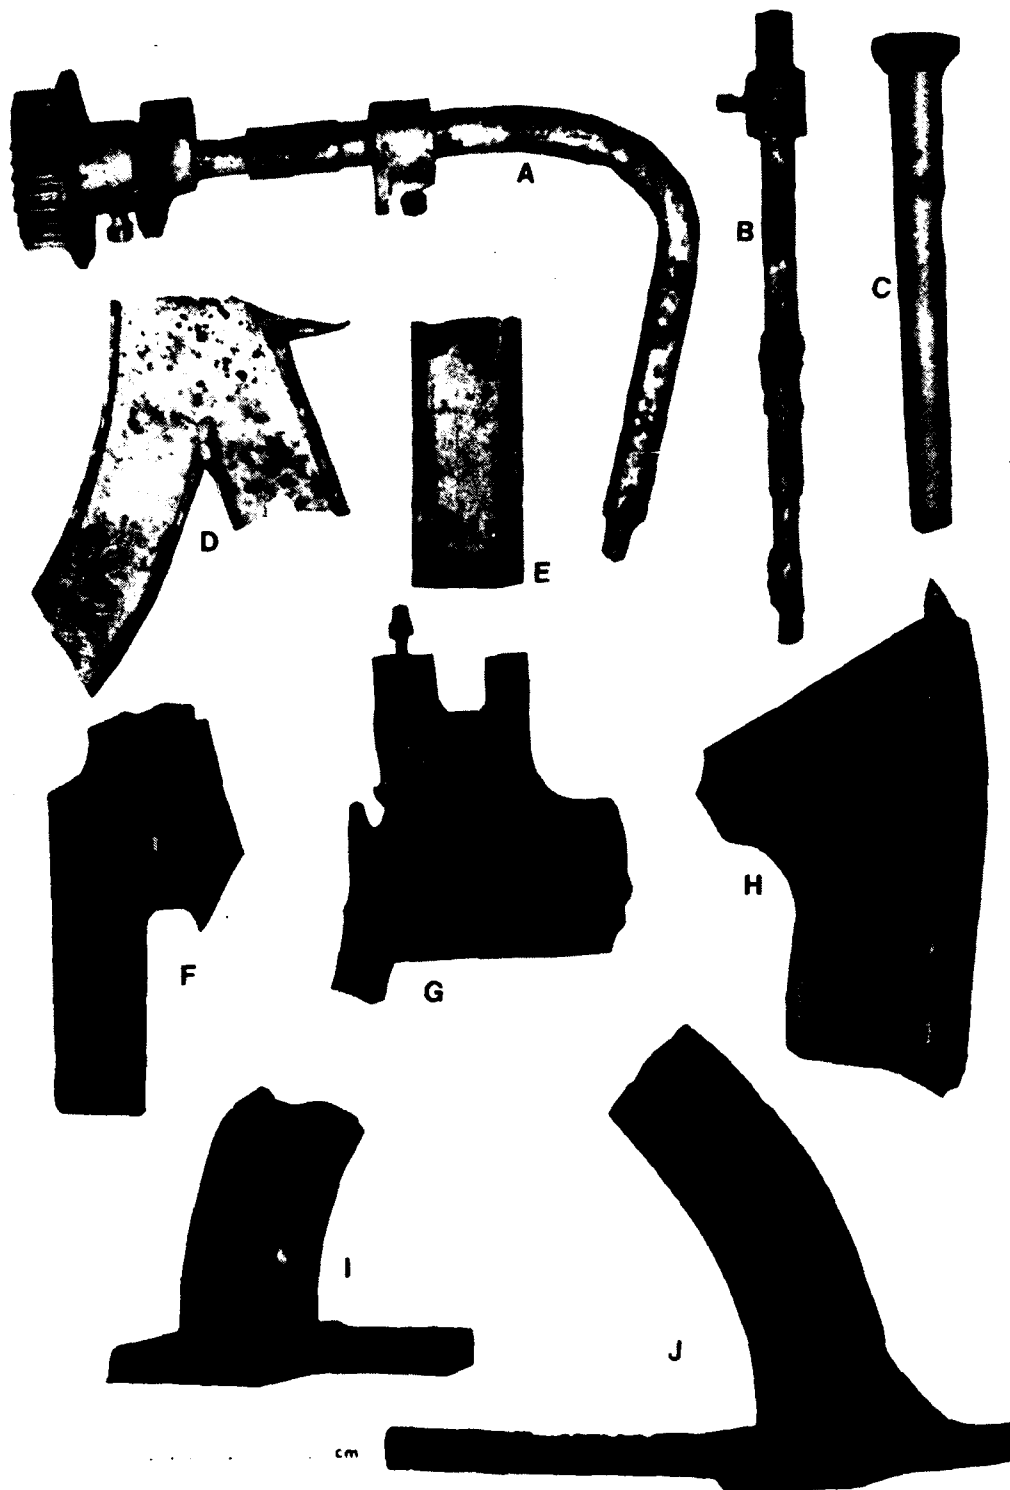
Machine Shafts and Machine Frame Parts (Page 391)

A)	F22-07-06B	machine shaft
B)	F22-07-06C	machine shaft
C)	F22-07-06F	machine shaft
D)	F22-08-01A	I bar
E)	F22-08-01A	I bar, footed
F)	F22-08-08A	T bar
G)	F22-08-02J	U bar, "C. DANF..."
H)	F22-08-03D	h bar
I)	F22-08-01B	I bar, footed
J)	F22-14	unknown stand

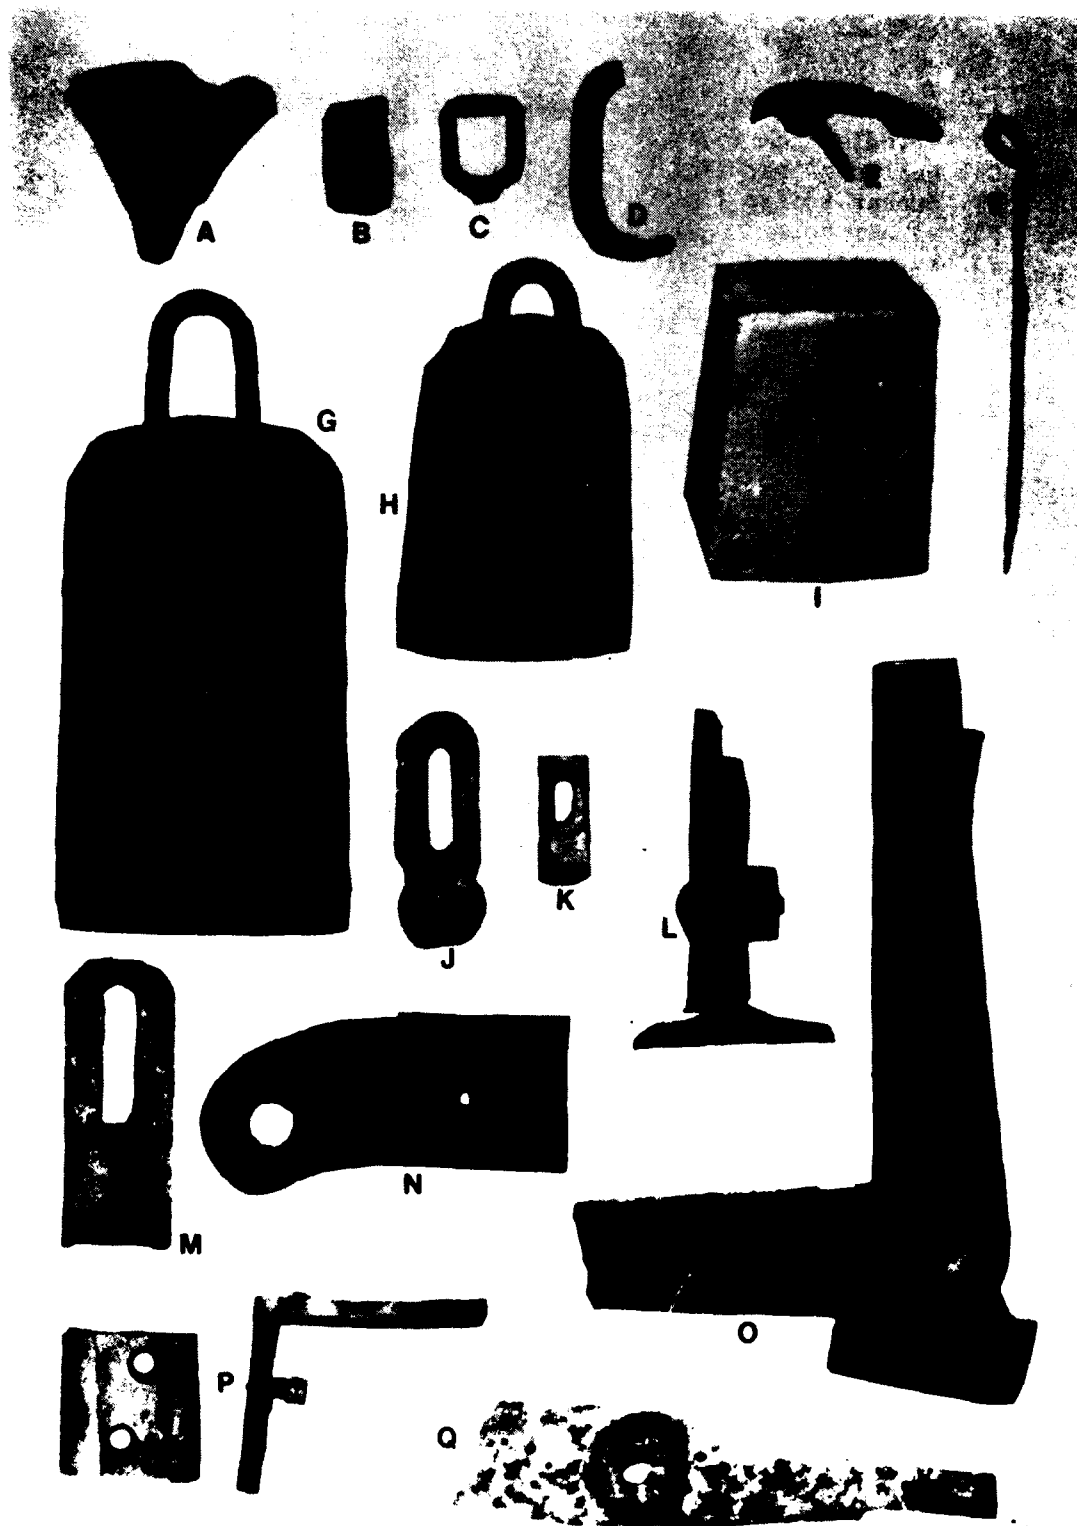
Weights and General Support Pieces (Page 393)

A)	F22-09-01A	oil cup
B)	F22-10-01D	weight
C)	F22-10-02A	stirrup weight hanger
D)	F22-10-03A	C shaped weight hanger
E)	F22-10-04A	saddle bar weight hanger
F)	F22-10-04C	saddle bar weight hanger wire
G)	F22-10-01B	weight
H)	F22-10-01A	weight
I)	F22-10-01C	weight
J)	F22-12-04E	L shaped, adjustable support
K)	F22-12-04B	L shaped, adjustable support
L)	F22-12-01A	T shaped, adjustable support
M)	F22-12-04A	L shaped, adjustable support
N)	F22-12-05A	curved, adjustable support
O)	F22-12-03A	angled, adjustable support
P)	F22-12-04D	L shaped, adjustable support and bracket
Q)	F22-12-07A	rocker arm
